Project Name:	Mountain Valley Pipeline	Inspector:	Matthew Grant
Inspection Date:	Tuesday, December 1, 2020	Project Contact:	Brian Clauto
Spread I: Franklin	ST114650+00-14760+00 ATWS 372, 373	Weather:	Wet

FIELD INSPECTION PHOTO LOG

Project Name: Mountain Valley Pipeline <u>Date</u>: Tuesday, December 1, 2020

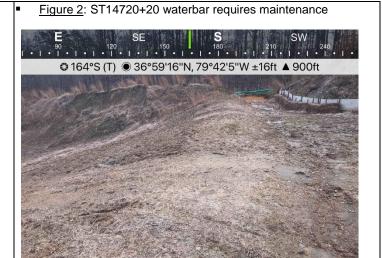
Figure 1: ST14698 waterbar requires maintenance

Routine Maintenance: (<u>72-Hour Deadline</u> from Notification) - N/A													
Ineffective Controls: (<u>24-Hour Deadline</u> from Notification) - ST 14960+00 waterbar requires maintenance, bar does not meet height requirement. - ST 14720+20 waterbar requires maintenance, bar does not meet height requirement. - ST 14726+95 waterbar requires maintenance, bar does not meet height requirement. Recommended Corrective Action: Maintain and install all controls per the approved PSS&S.
